AIRCRAFT ACCIDENT INVESTIGATION BOARD

FINAL AIRCRAFT ACCIDENT REPORT FOR A CESSNA 172M, 9J – GRO THAT OCCURRED IN MKUSHI (MASEBE RANCH), ZAMBIA ON 7th SEPTEMBER, 2021

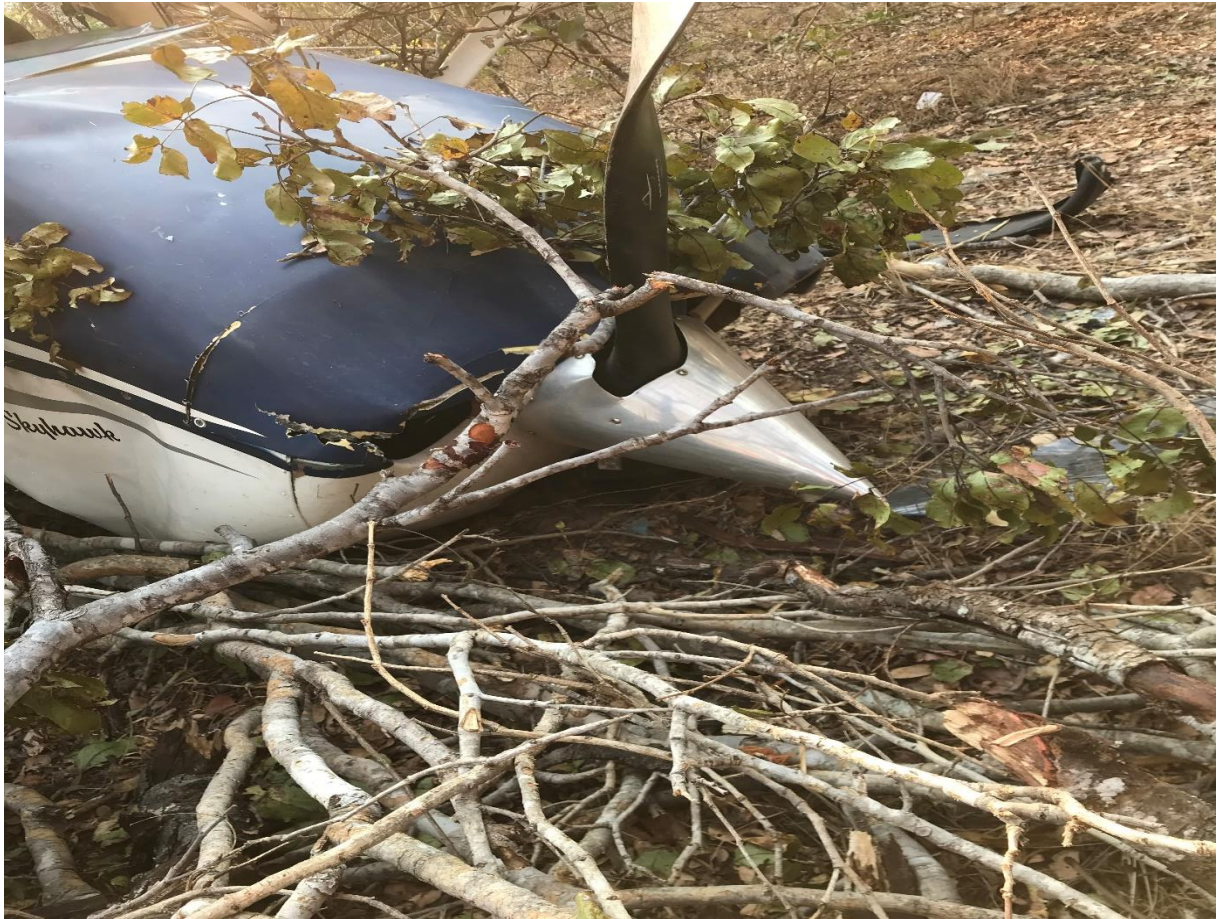
- a) The Nose Section was damaged including propellers and nose landing gear was detached from aircraft. (Fig .1) and (Fig. 2)
- b) Certain portions of the instrument panel collapsed and detached. (Fig. 3)
- c) One (01) left control yoke detached from control stick/panel. (Fig. 3)
- d) The engine controls (Throttle and Mixture lever) were bent. (Fig. 3)
- e) The wings of the aircraft were damaged especially the right side wing including secondary controls surface (flap), with detached wing tip and punctured fuel tank.(Fig. 4)
- f) Damaged tail and left wing (Fig.5)
- g) The tail section was bent. (Fig. 6)
- h) The entire fuselage section had several hard points damaged due to impact with trees and the ground (Fig. 6)
- i) Windshield broken and detached from the cockpit. (Fig.7)

Fig .1: Nose Section and Propellers Damaged

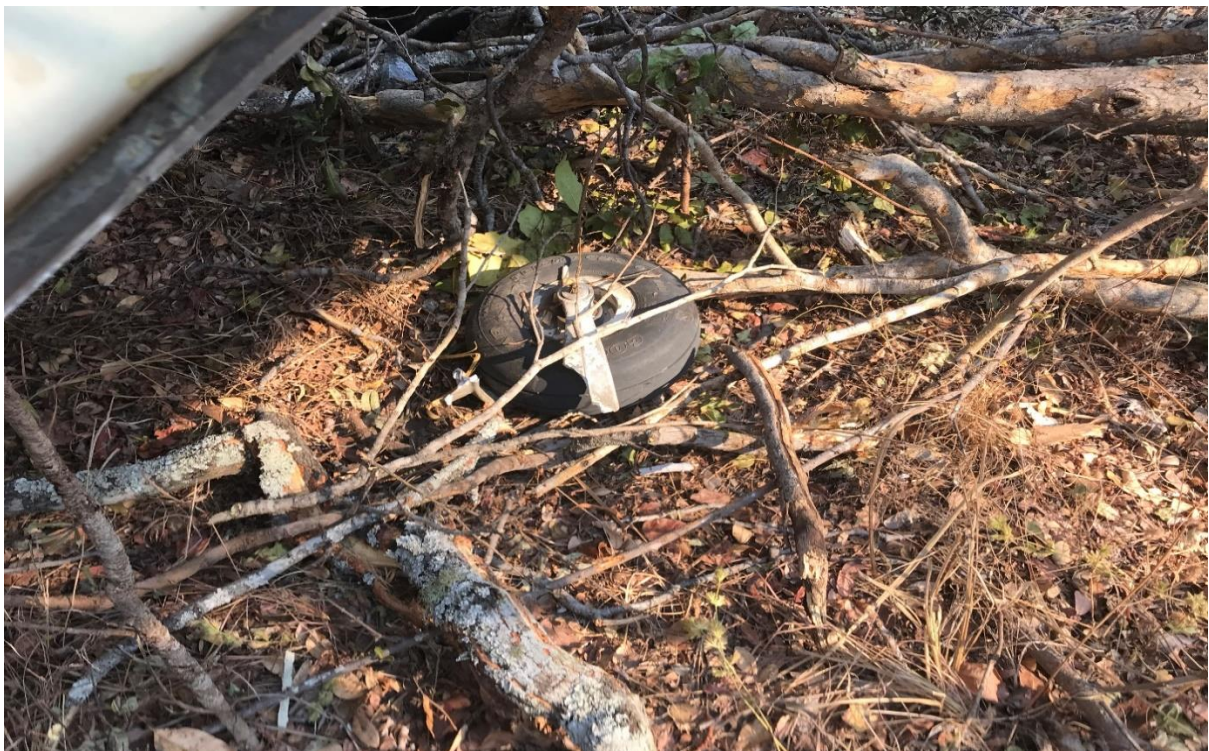
Fig. 2: Nose Landing Gear Detached from Aircraft

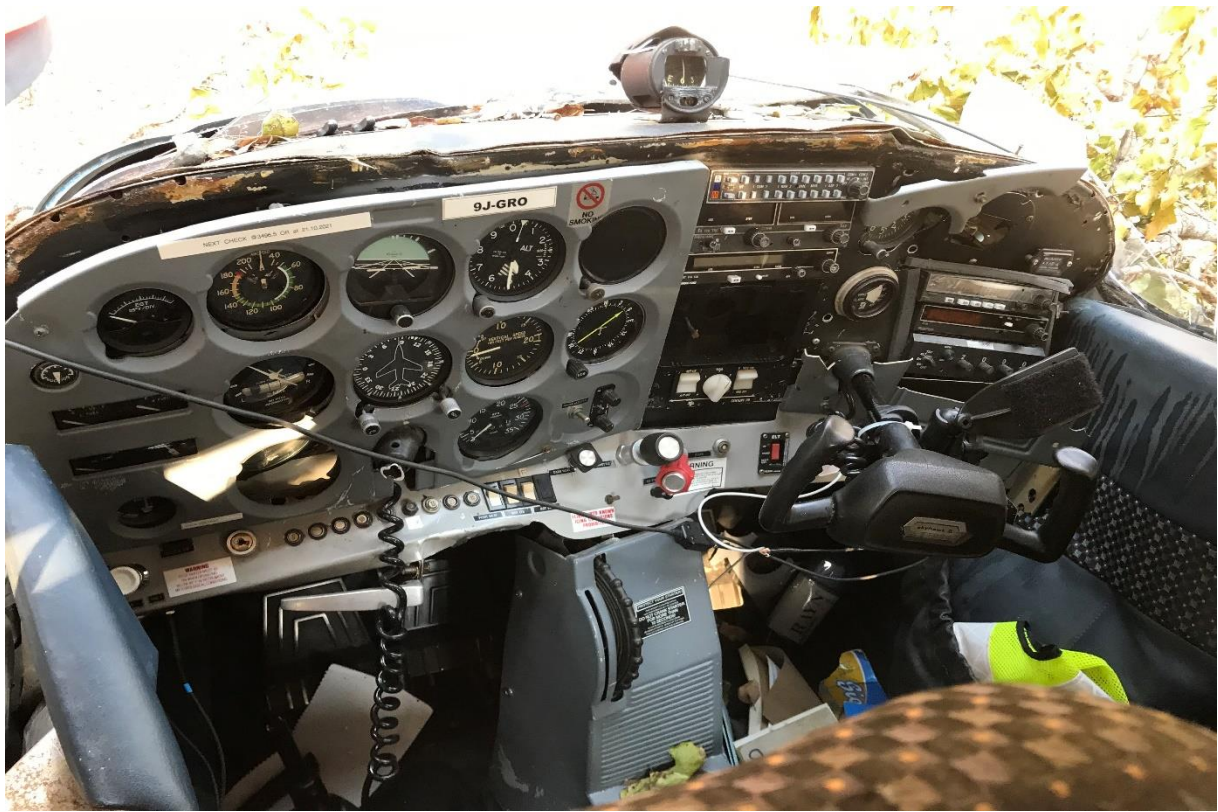
Fig .3: Instrument Panels Collapsed and Detached, One (01) Left Control Yoke Detached from Control Stick/Panel, The Engine Controls (Throttle and Mixture Lever) Bent

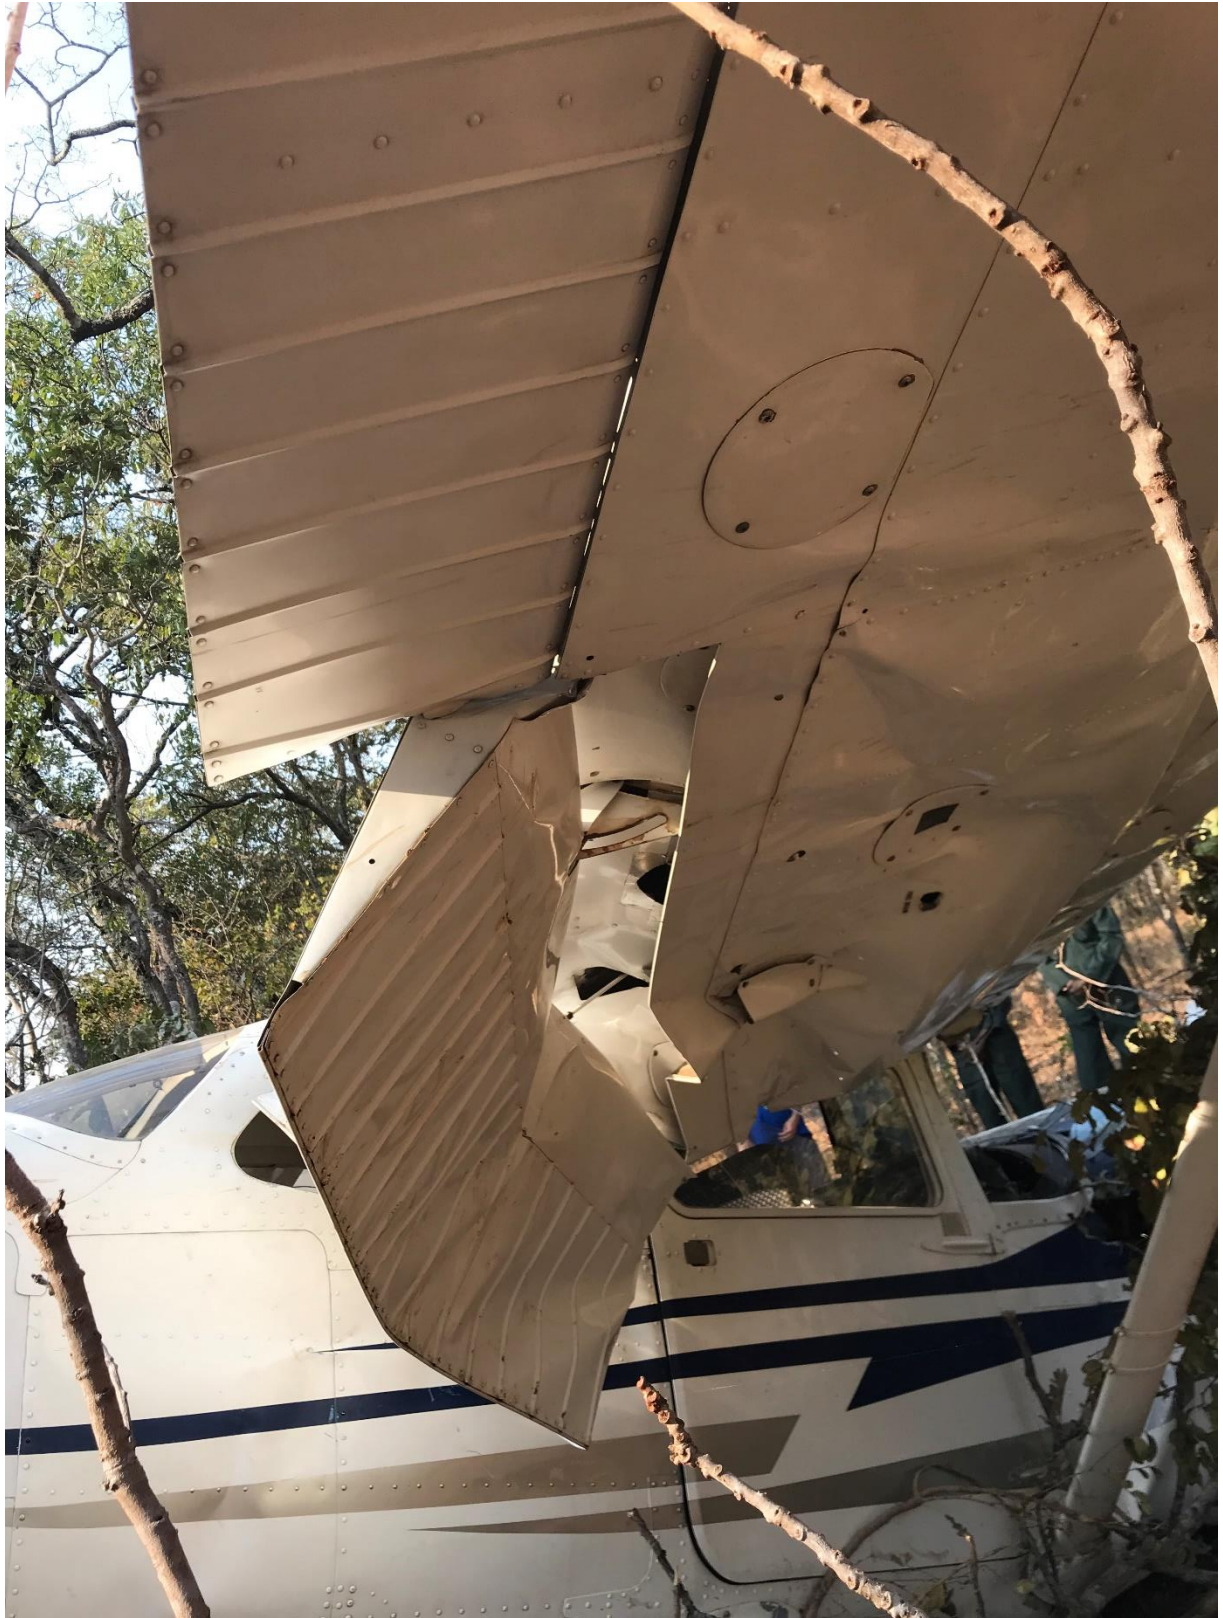
Fig. 4: Wings and Secondary Control Surface (Flap) Damaged, Detached Wing Tip and Punctured Fuel Tank

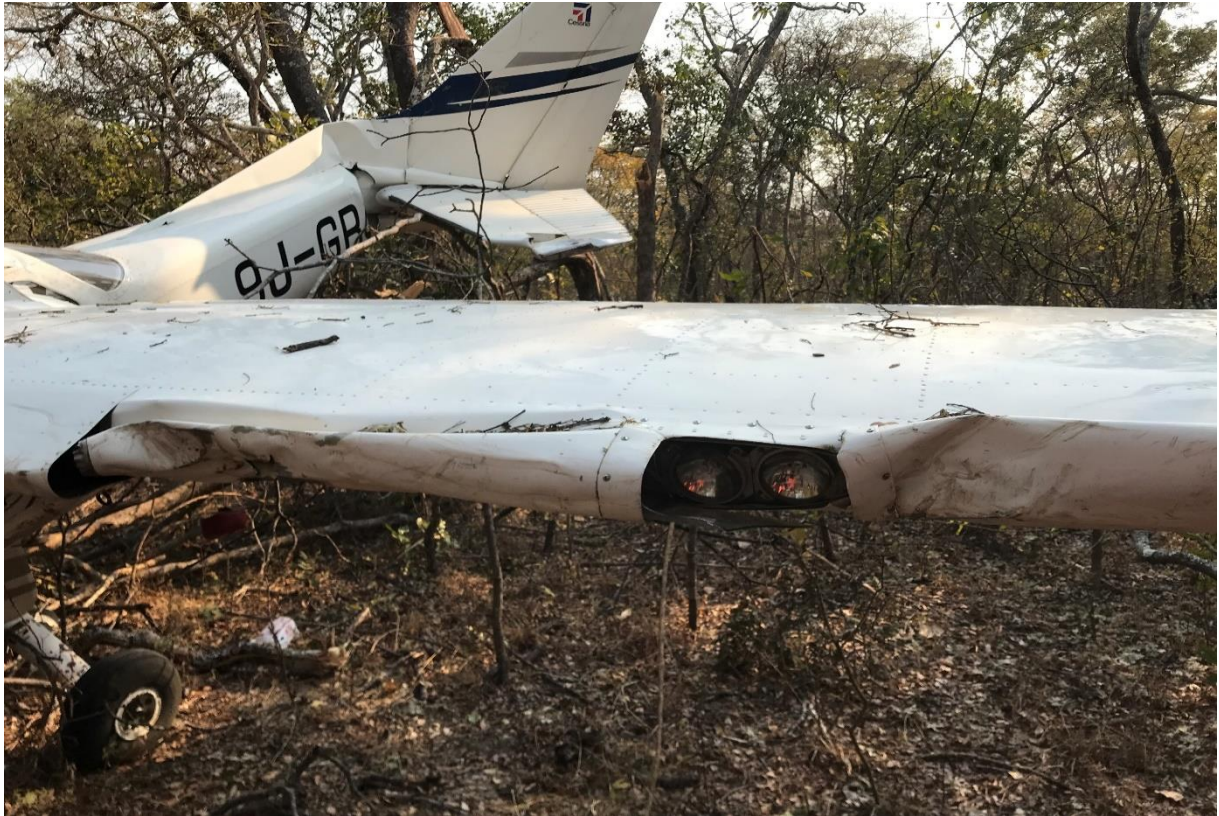
Fig. 5: Damaged Tail and Left Wing

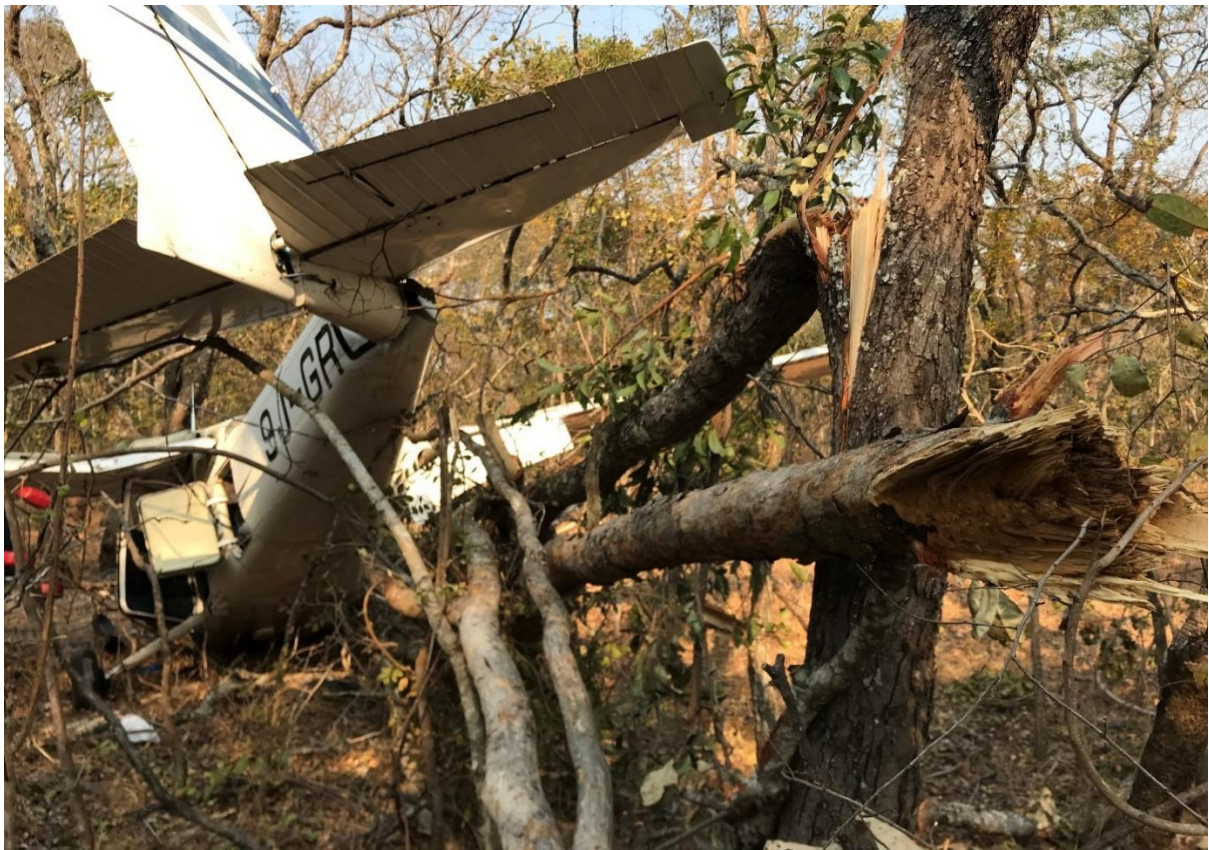
Fig. 6: Tail Section Bent

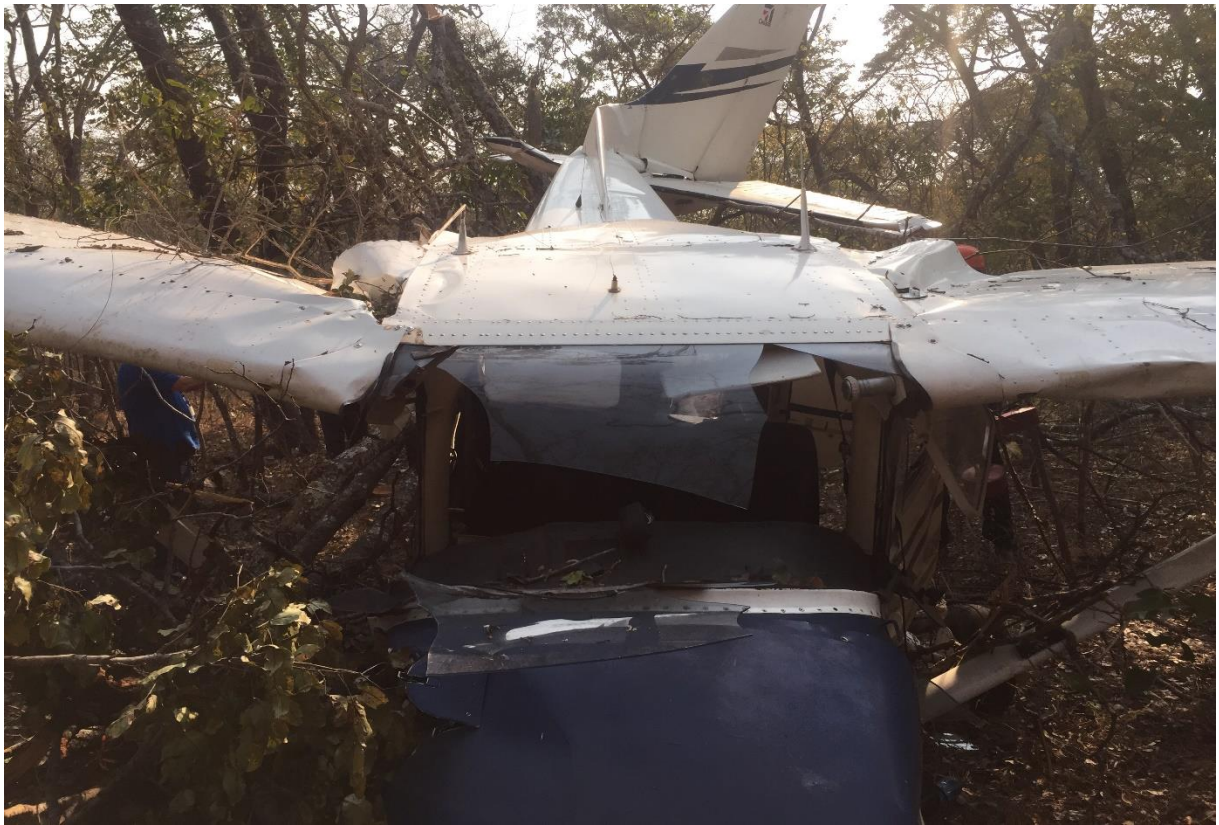
Fig. 7: Broken Windshield
