AIRCRAFT ACCIDENT INVESTIGATION BOARD

FINAL AIRCRAFT ACCIDENT REPORT FOR A PIPER PA-32-300 CHEROKEE SIX, 9J – RDN THAT OCCURRED IN MULOBEZI, WESTERN PROVINCE, ZAMBIA ON 27th FEBRUARY, 2022

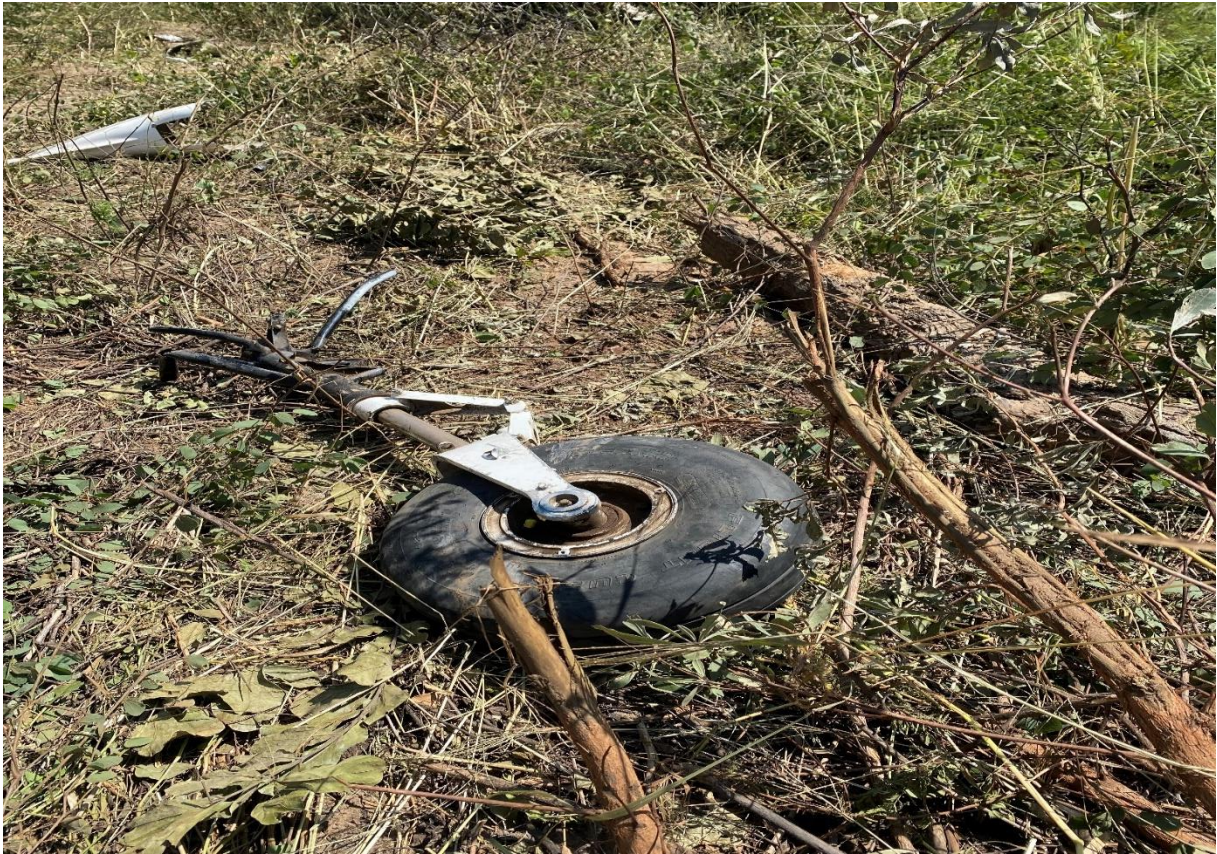
- a) Nose landing gear detached from the Airframe (Fig.1)
- b) Right hand main landing gear detached from the wing tearing off the attachment area (Fig.2)
- c) Right wing tip detached from the wing (Fig.3)
- d) Left wing compressed, folded in several sections and partially split at the wing root area with some pieces of frames broken off and spread around the accident scene (Fig.4)
- e) The tail cone around the base of the fin dented and tip of the fin slightly damaged (Fig.5)
- f) Propeller blade tips bent backwards and scratched (Fig.6)

Fig.1: Nose Landing Gear Detached from the Airframe

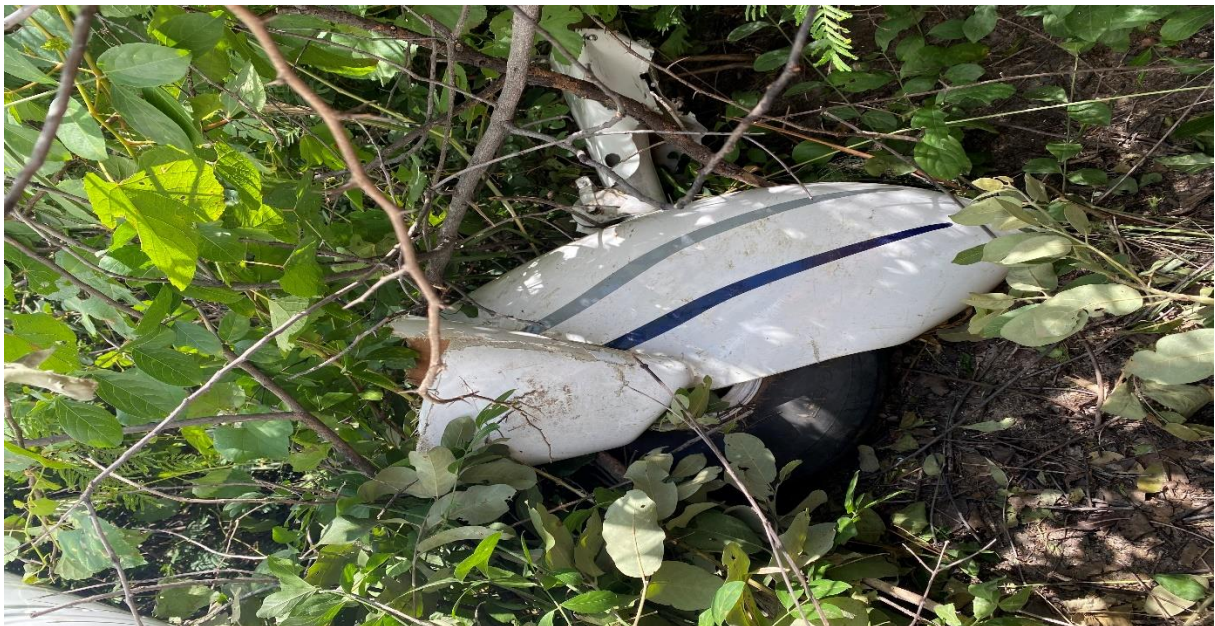
Fig.2: Right Hand Main Landing Gear Detached from the Wing

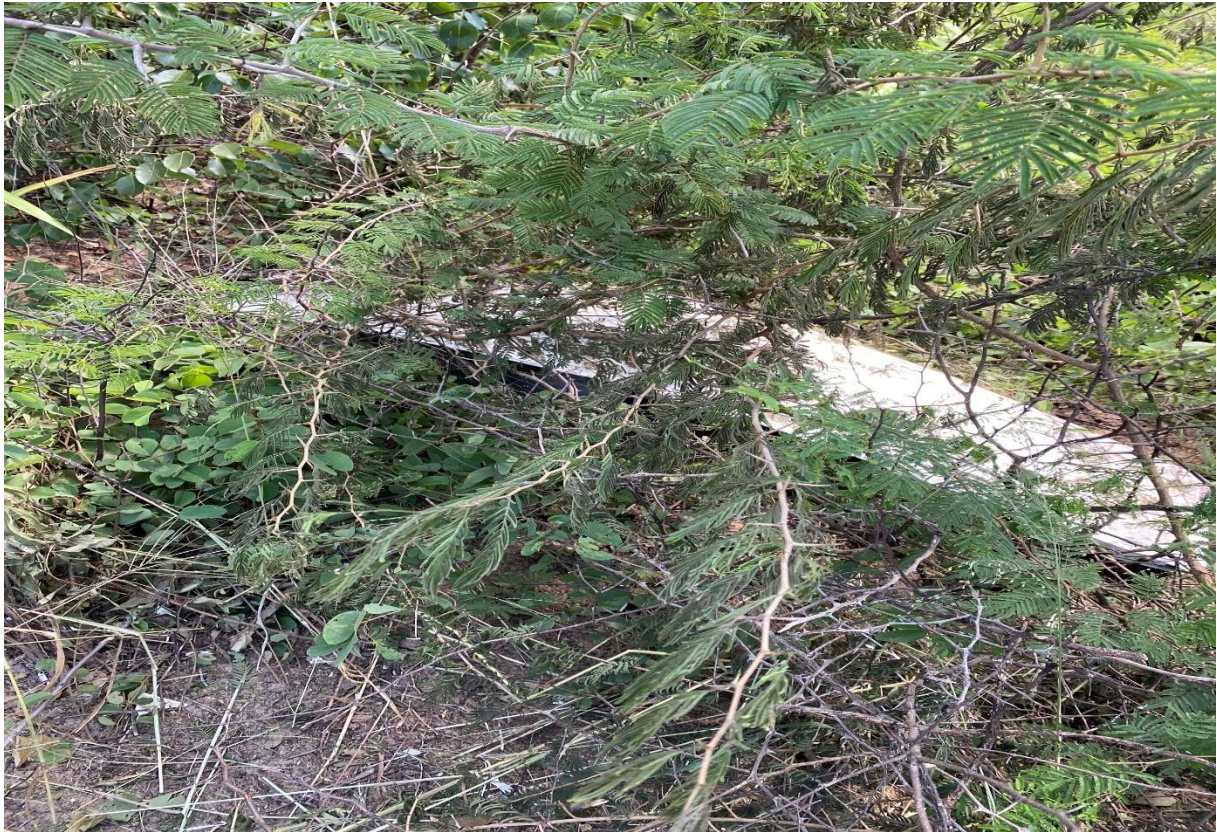
Fig.3: Right Wing Tip Detached from the Wing

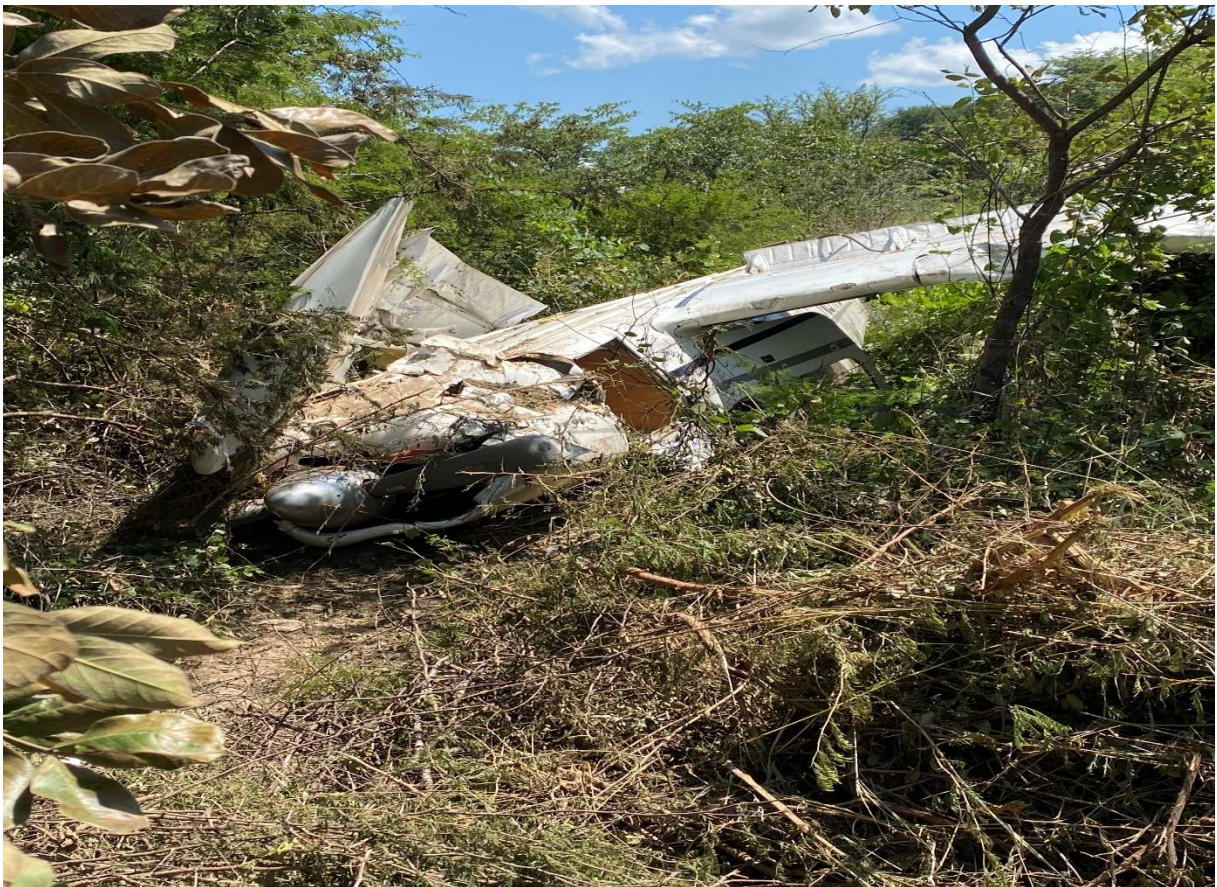
After clearing the trees, the aircraft veered to the right where it hit a shrub and flipped on its back and bending the left wing forward as it came to rest upside down facing opposite its final flight path among the shrubs.

Fig 4: Left Wing Compressed, Folded in Several Sections and Partially Split at the Wing Root Area with Some Pieces of Frames Broken off and Spread.

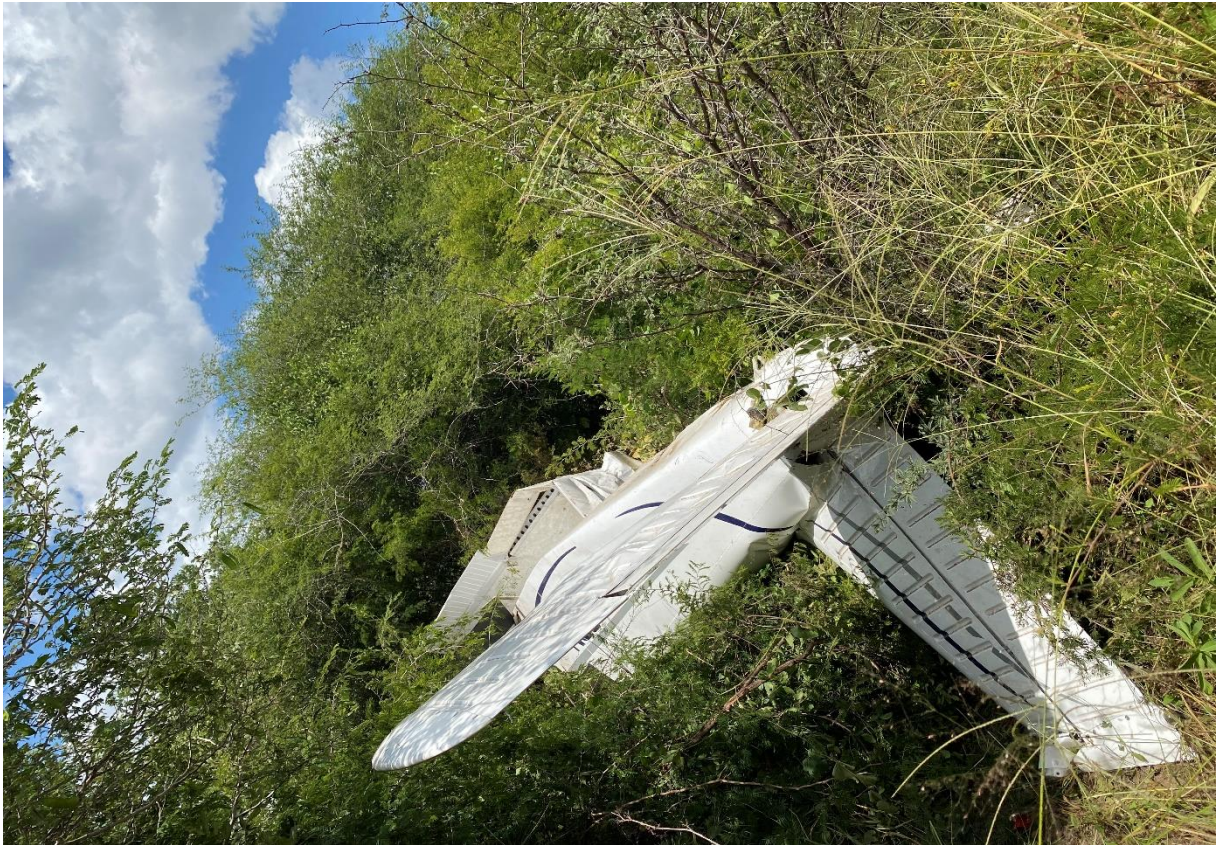
Fig.5: The Tail Cone Around the Base of the Fin Dented and the Tip of the Fin Slightly Damaged

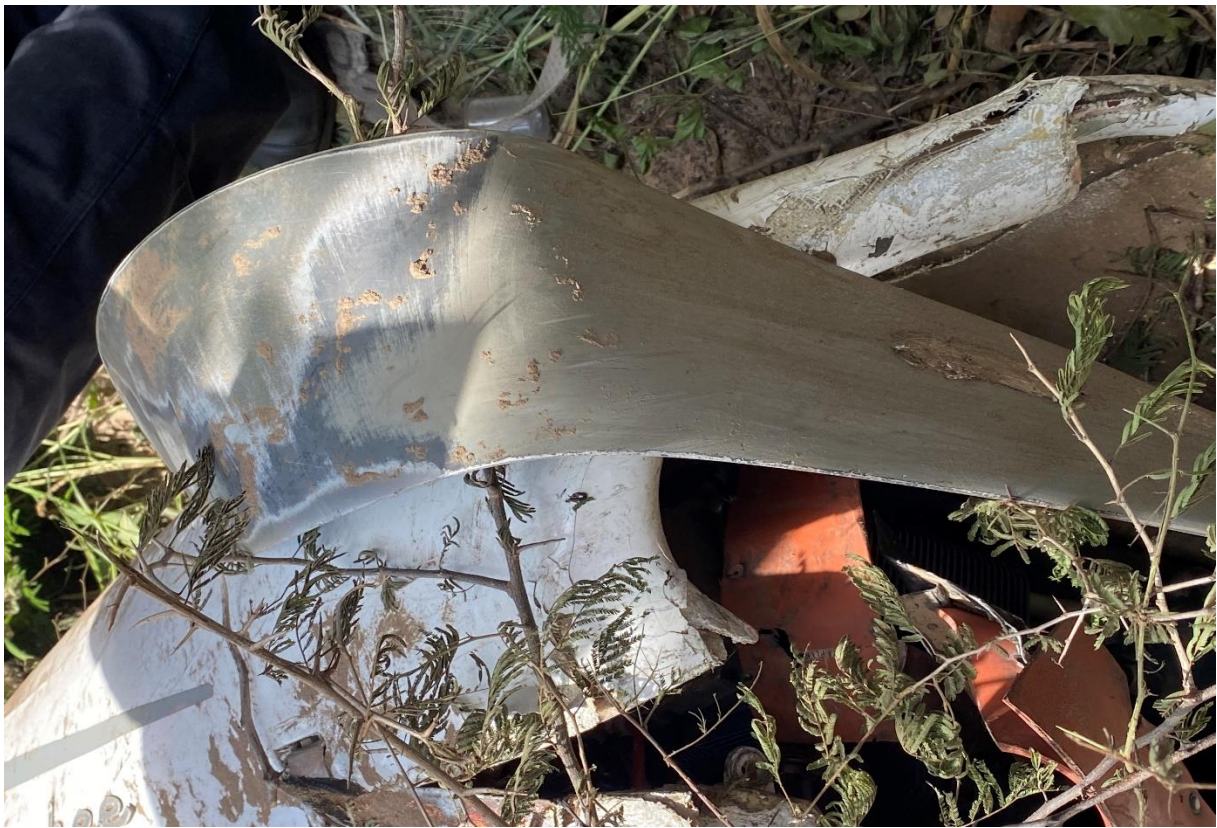
S/N	COMPONENT	STATE FOUND		COMMENT
01	Propeller (fig.6)	Both propeller blades had paint scratched on upper surface tips, bent and folded backwards at the tips		This indicates that the propeller was still spinning at impact.
02	Fuel Divider (Fig.7)	Diaphragm clean and not collapsed		Fuel system not blocked and fuel was flowing.
03	Spark Plugs (Fig.8)	Top Left	clean	All top spark plugs were firing. Bottom spark plugs found clean indicate firing, however, the plugs found with oil could be a result of the leaning position of the aircraft as oil remaining in the pipes collects and settles in its circulation process. Further, this could also be a result of residue oil settling due to sudden stoppage.
		Top Right	clean	
		Bottom left	1 had oil	
		Bottom right	All had oil	
04	Throttle, Mixture and Propeller levers	All links connected		This indicates that the throttle, mixture and propeller controls were working and responsive.

- d) **Mechanical linkages** – the three power levers (propeller, throttle and mixture) were connected and functioning normally.
- e) **Propellers** – the investigation finds that the state of the propeller as evidenced by the the tips whose paint was scratched from leading to trailing edge and bent backwards in the same pattern indicates that the engine was still running at impact.

Fig.6: Propeller Blades Bent Backwards and Scratched at the Tip

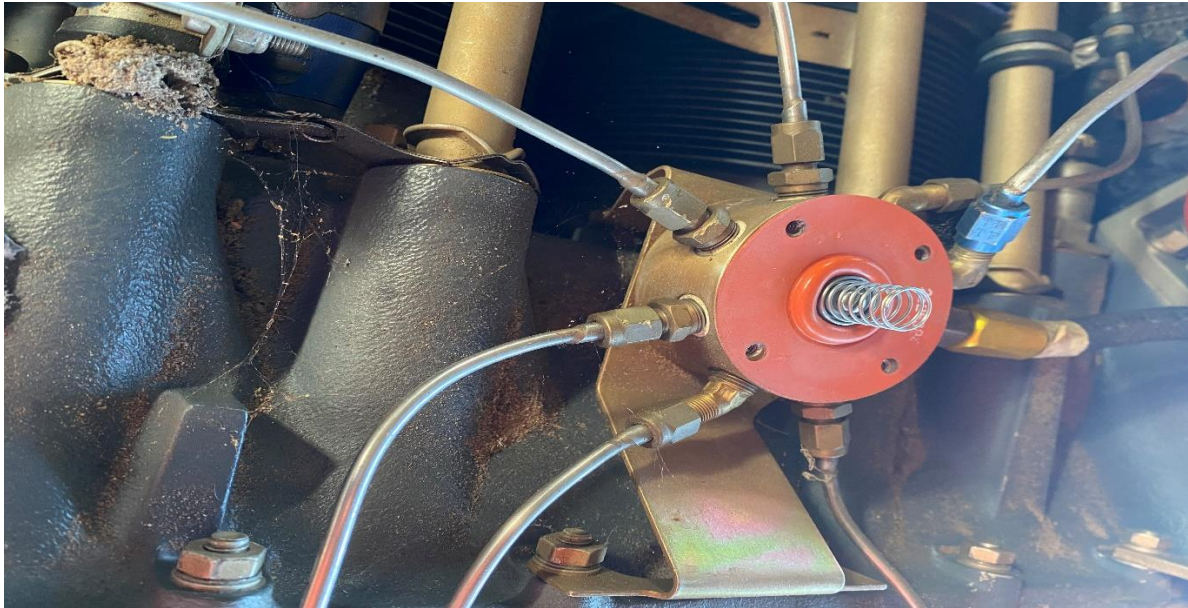
Fuel flow divider was found clean and the diaphragm did not collapse – this indicates that there was no blockage and fuel was flowing.

Fig.7: Fuel Flow divider and diaphragm intact

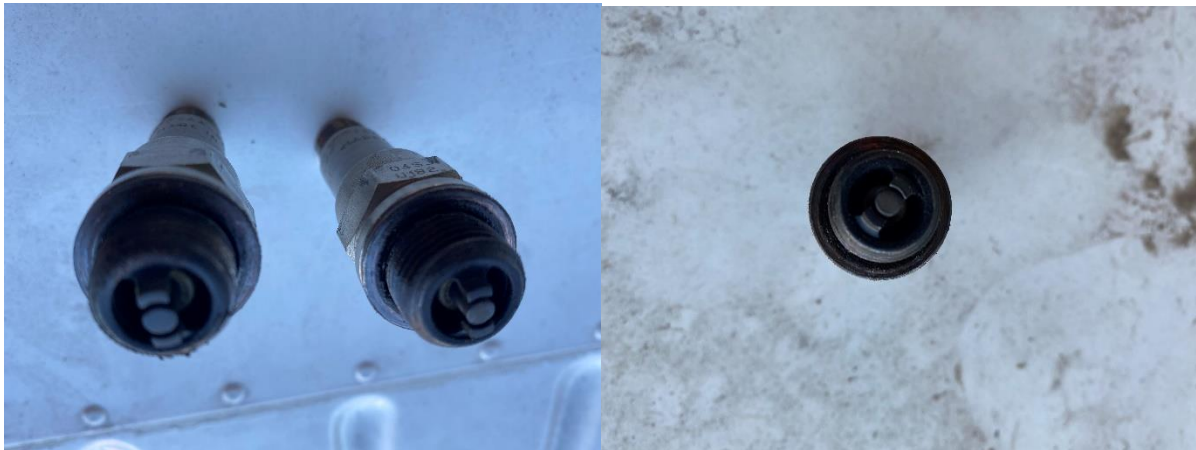
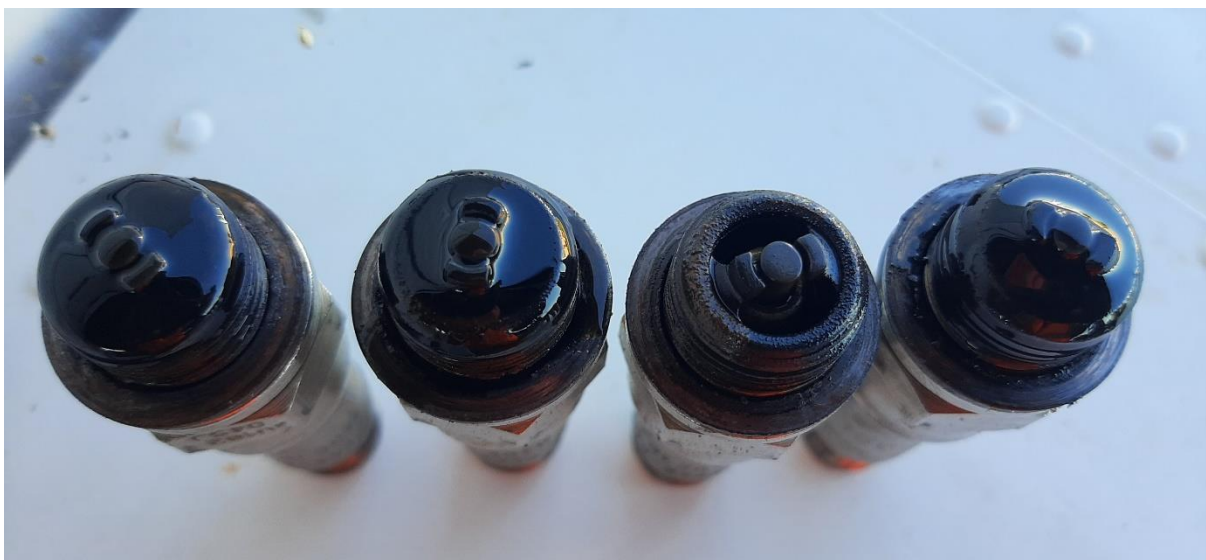
- b) **Ignition system failure** – The investigation finds that the ignition system did not fail as the top spark plugs were serviceable. The bottom plugs were found with oil and the investigation team concludes that this was due to residual oil which had settled as a result of the position of rest or sudden stoppage. The high tension power cables were found intact. In addition, the driving mechanism of the magnetos was found to be in working order.

Fig.8: Some Spark Plugs Found with and without Oil
